# Westside Station, Tallahassee, FL: Delivery Operations

## AUDIT REPORT

Report Number 24-085-3-R24 | June 7, 2024

**SUBJECT:** Audit Report – Westside Station, Tallahassee, FL: Delivery Operations  
(Report Number 24-085-3-R24)

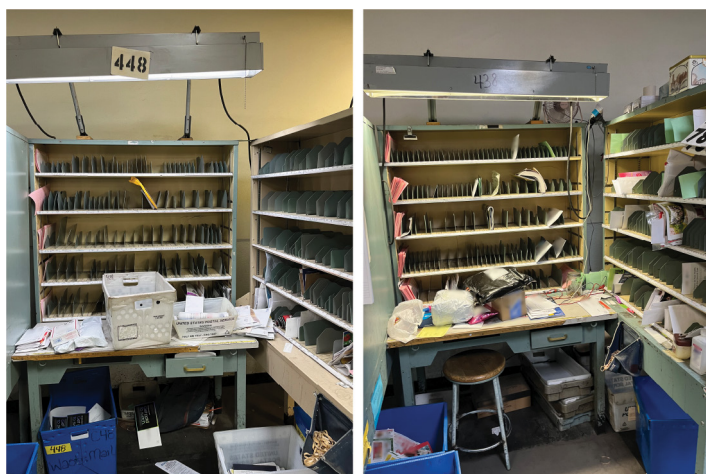
**Figure 2. Examples of Delayed Mail in the Carrier Cases**

On the morning of April 2, 2024, we identified 1,539 delayed mailpieces<sup>13</sup> at 29 carrier cases. Specifically, we identified 790 flats, 693 letters and 56 packages. See Figure 2 for examples of delayed mail found at carrier cases. In addition, management did not report this mail as undelivered in the Delivery Condition Visualization (DCV)<sup>14</sup> system. Further, the carriers were not using Postal Service (PS) Forms 1571, Undelivered Mail Report,<sup>15</sup> to document the undelivered mailpieces.

Management did not provide adequate oversight to verify that all mail was cleared from the unit. The station manager stated that management relied on carriers to complete their deliveries, as instructed, and as a result, did not verify whether the closing supervisor conducted a walkthrough to check for delayed mail. Unit management did not report delayed mail in the DCV system or require carriers to complete PS Form 1571 because they had not

*Delayed Mail:* Management will conduct a standup talk on the proper use of PS Form 1571 to identify any mail left at carrier cases. A service talk will also be given to local management on the proper handling of delayed mail and recording in DCV. Additionally, management at the district level will conduct reviews to monitor for compliance.

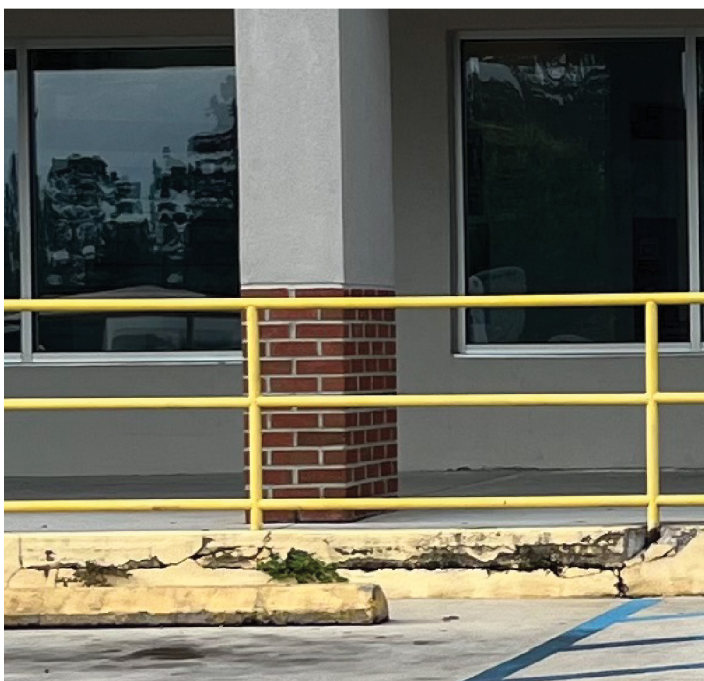
### Figure 3. Deteriorating Handrail in Front of Building

- Thirteen fire extinguishers missing monthly and annual inspections. Four fire extinguishers were missing monthly tags, three were not mounted, and one was blocked.
- Three unsecured ladders on the workroom area.
- Handicap rail concrete support in front of the customer entrance deteriorating and posing a potential fall hazard to customers (see Figure 3).
- Several electrical sockets and light switches missing plate covers or broken (see Figure 4). Several junction boxes also missing covers.

Management did not provide sufficient oversight and take the necessary actions to verify that property condition issues were corrected because other duties, such as getting the mail out for delivery each day, took priority over addressing maintenance issues. Additionally, management was in the process of working with the landlord to fix some building issues.

*Property Conditions:* Management has begun abating the property condition issues and will submit work orders for repairs required by other resources.

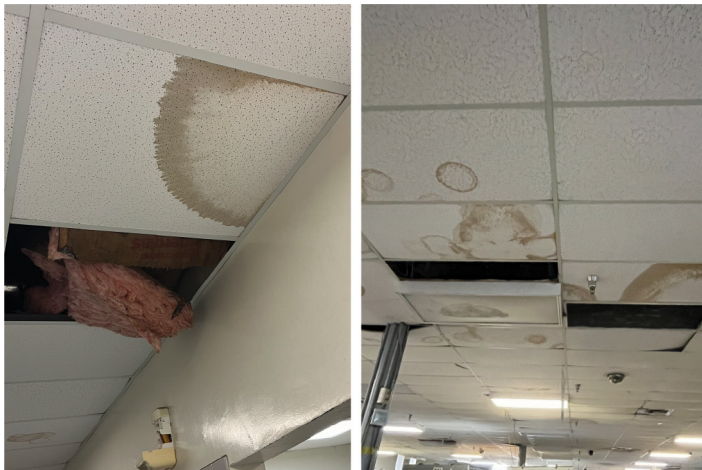
**Figure 5. Stained and Missing Tile in Men's Restroom and Workroom Areas**

- Walls throughout the facility such as lobby and workroom floor needed repainting.
- Several lights on the workroom floor not working due to numerous leaks from the roof.
- Loading dock area with damaged gutter allowing rain to trickle down where carriers load their vehicles.
- Parking lot needed resurfacing and parking bumpers deteriorating.
- Multiple stained, missing, broken, and misaligned ceiling tiles throughout the facility (see Figure 5).

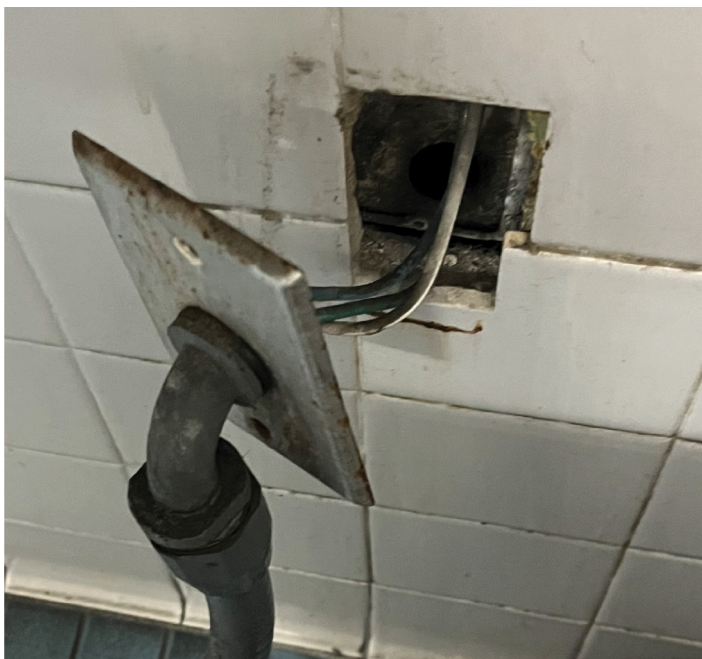
**Figure 6. Loose Water Pipe Socket in Men's Restroom**

- A loose water pipe socket in men's bathroom (see Figure 6).
- Broken floor tiles in customer lobby (see Figure 7).
